RE: Site Inspection, Round Valley Rock, Inc., Round Valley Rock Quarry, S/029/004, Morgan County, Utah

Date of Inspection: April 24, 2002
Time of Inspection: 10:30 to 11:00 AM
Conditions: Clear, 50's
Participants: Paul Baker, DOGM; Joseph Rees, Round Valley Rock

S/029/004, Round Valley Rock Quarry, Round Valley Rock, Inc.

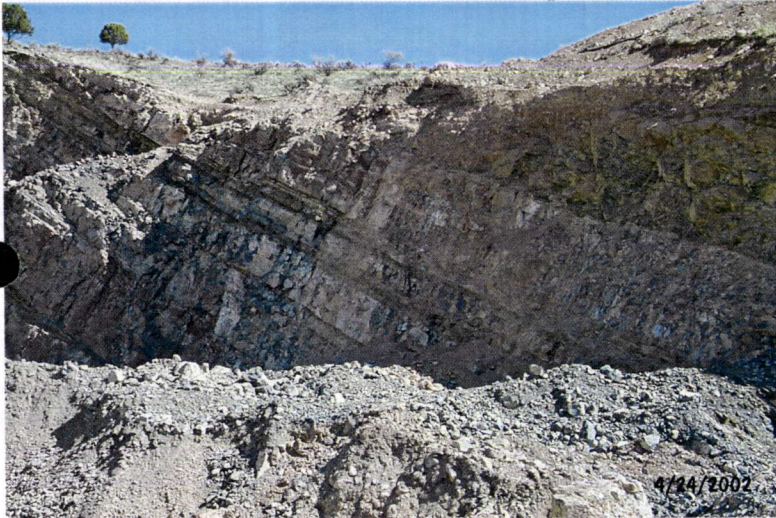
We paced part of the pit area and made a gross estimate of the quarry size from that measurement. The quarry itself appears to be no more than about two acres. There are additional disturbed areas, but I do not believe they are larger than about two additional acres for a total of four acres. The operator is able to extract a large amount of rock from a relatively small area because of the height of the highwall (Photo 1 through 3).

Photo 1. View looking approximately east at part of the highwall

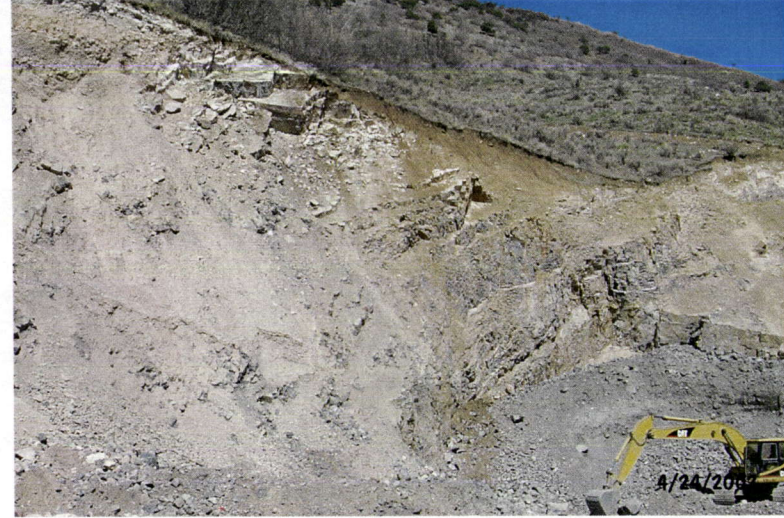
There is not a lot of topsoil available to be salvaged, but there is some, particularly in the drainages (Photo 3).

Photo 3. Note the soil in the swale.

Because there is a limited amount of soil in the area, any available soil, such as that shown in Photo 3, should be salvaged for later use in reclamation.

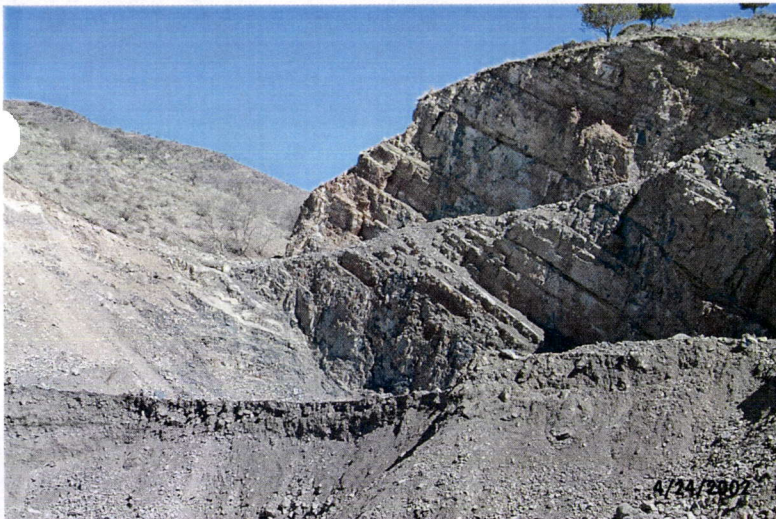
Photo 2. View looking approximately north at the highwall.
